Appendix 5

Photograph Log and Photographs

Photograph Log

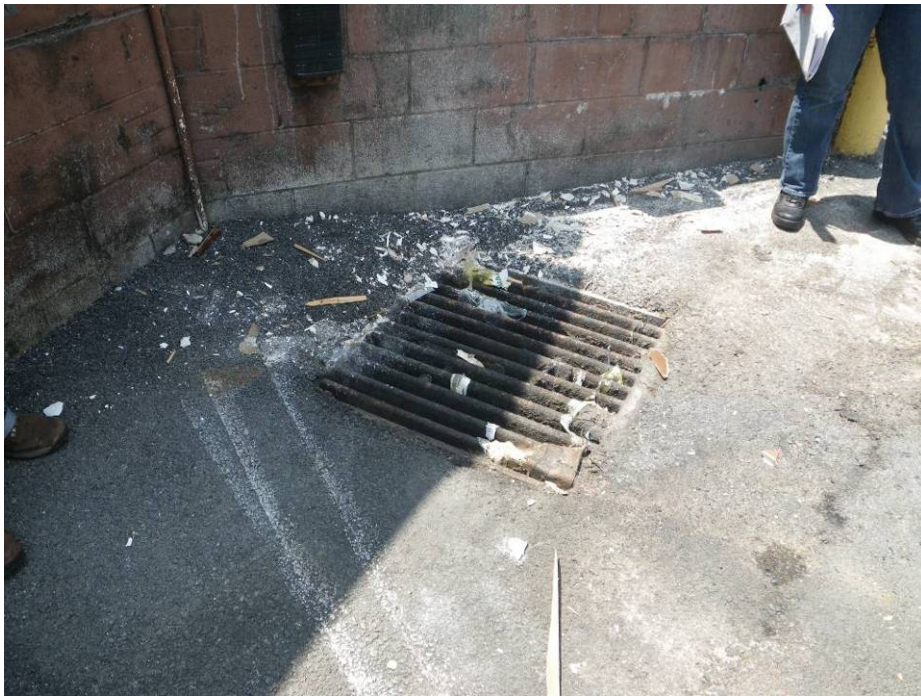
Photograph 34. Outfall 56 - Smallwood Village Shopping Center: Debris and pavement stains at storm drain inlet behind Smallwood Village Shopping Center.

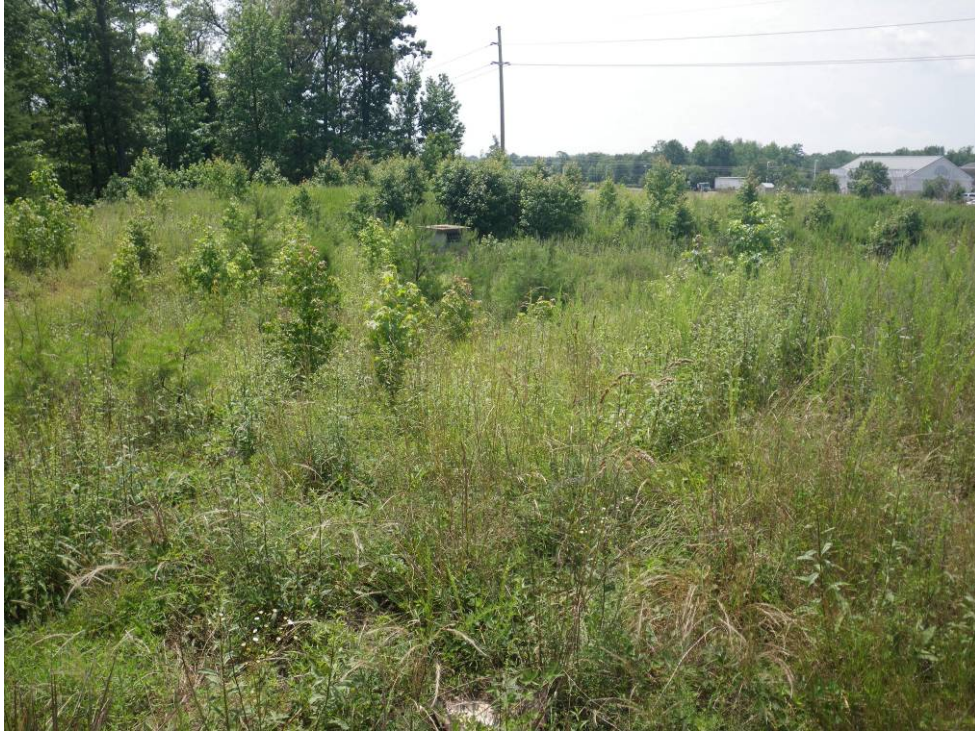
Photograph 35. **Billingsley Road: Overgrown vegetation in the dry detention pond surrounding the riser structure.**

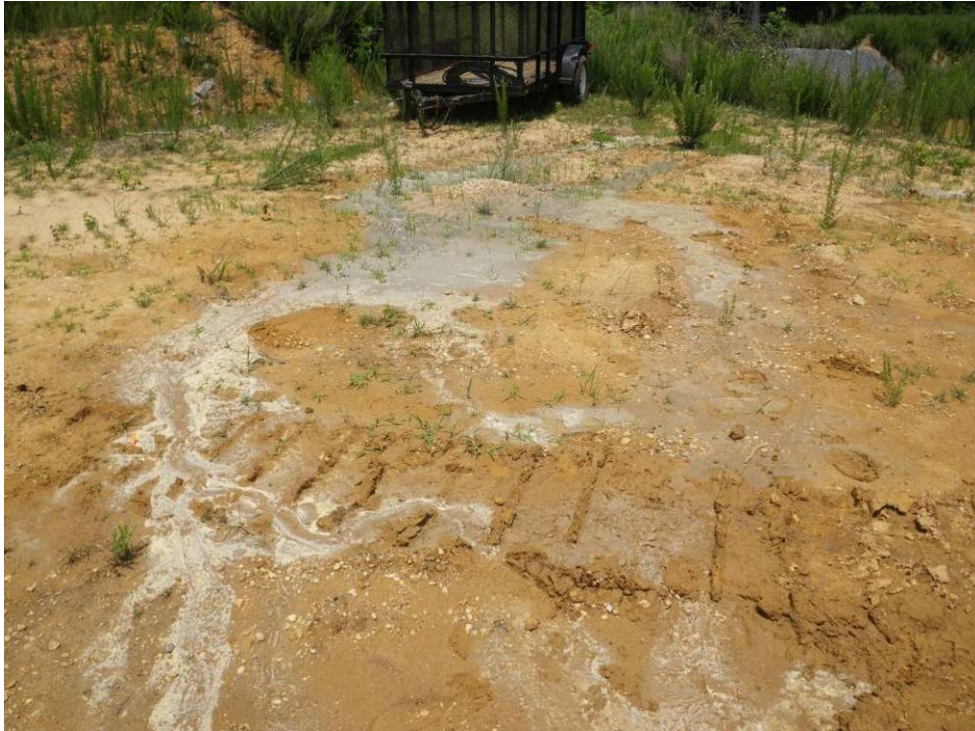
Photograph 36. **New High School Construction Site: Concrete washout residue near Sediment Trap 3.**

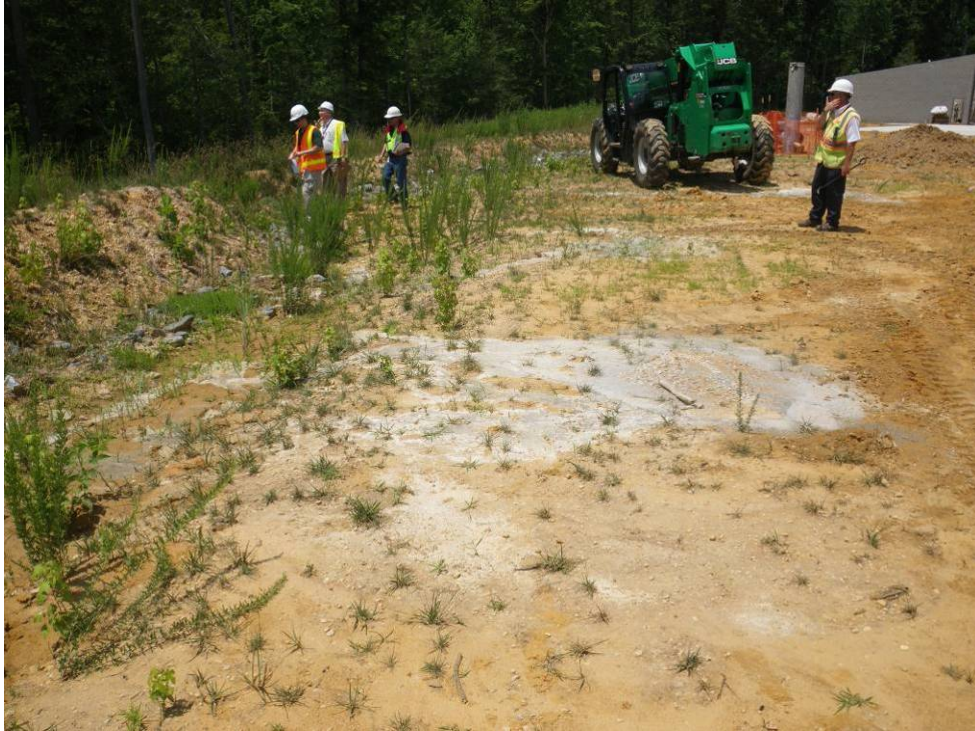
Photograph 37. **New High School Construction Site: Concrete washout residue in northern swale leading to Sediment Basin 1.**

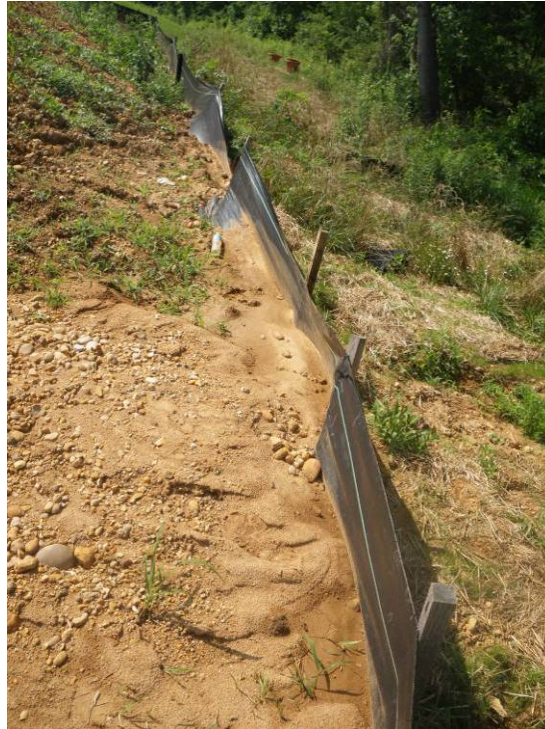
Photograph 38. **Leighland Meadows Construction Site: Sediment accumulation against and on top of silt fence at the back of Lot 9.**

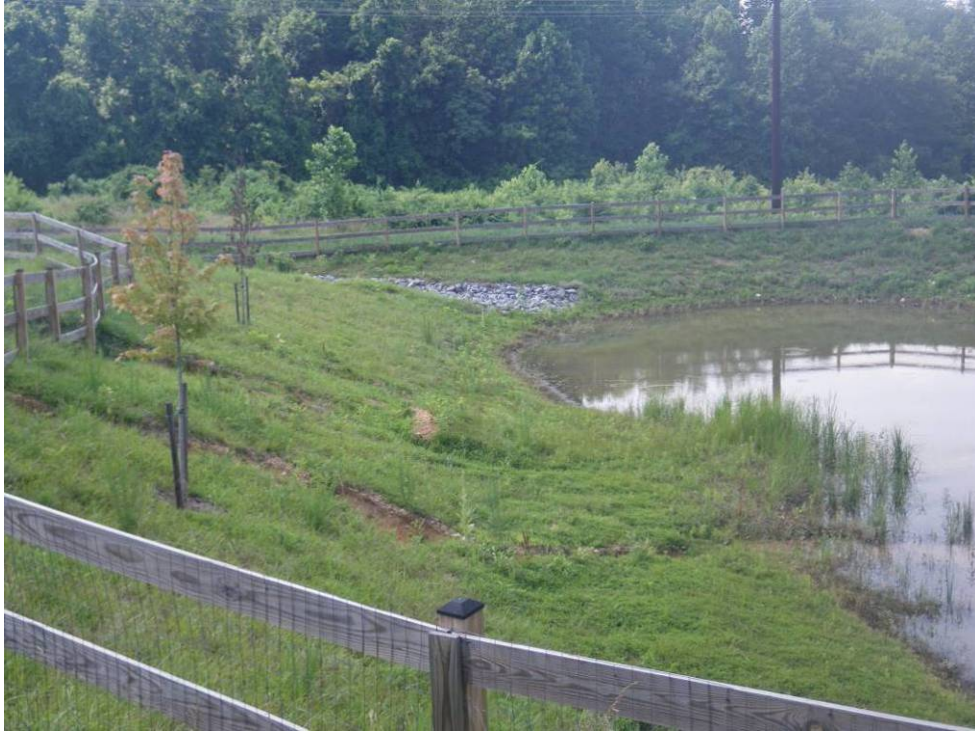
Photograph 39. Leighland Meadows Construction Site: Erosion on the banks of Sediment Trap 3.

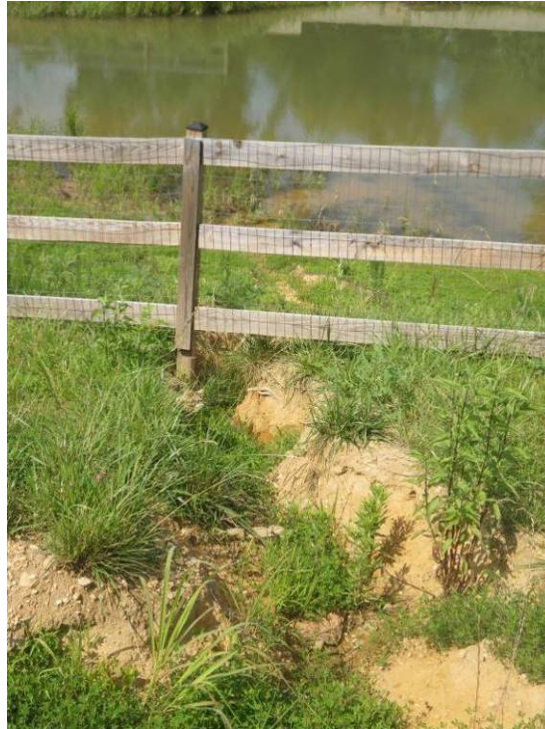
Photograph 40. Leighland Meadows Construction Site: Close up view of eroded area shown in Photograph 39.

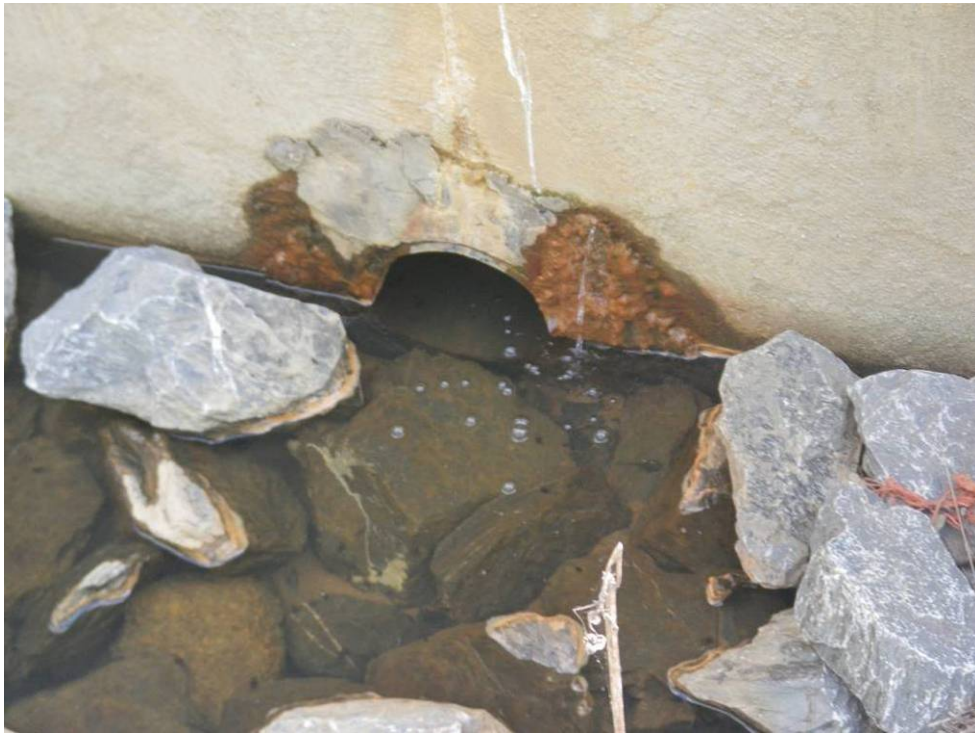
Photograph 41. **Leighland Meadows Construction Site: Water leaking through weir wall of Sediment Trap 3.**
